UV-Nanoimprint Mold Repair by Ga⁺ Focused-Ion-Beam

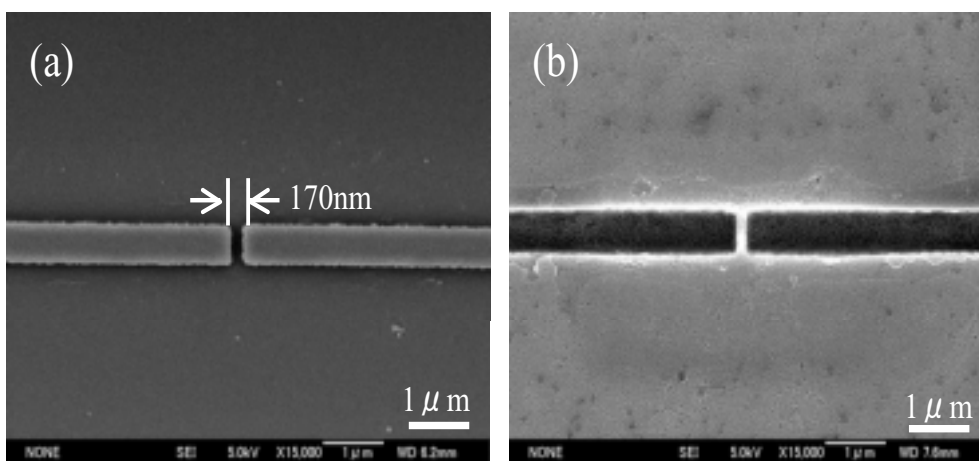
Next, we show how to repair a hollow-defective mold by FIB-CVD. First, we fabricated a hollow-defective line on a quartz substrate by electron beam (EB) lithography and reactive ion etching (RIE) as shown in Figure 2(a). The linewidth and hollow-width were 650 nm and 170 nm. UV-NIL was carried out using the defective mold on the UV-NIL resin PAK-01 (Toyo Gosei Co.) layer coated on Si substrate. The imprinted result is shown in Fig. 2(b). The defective line was clearly imprinted.

Fig.2 SEM images of (a) the hollow-defective line on the mold and (b) the imprinted line onto PAK-01/Si substrate using the defective mold.

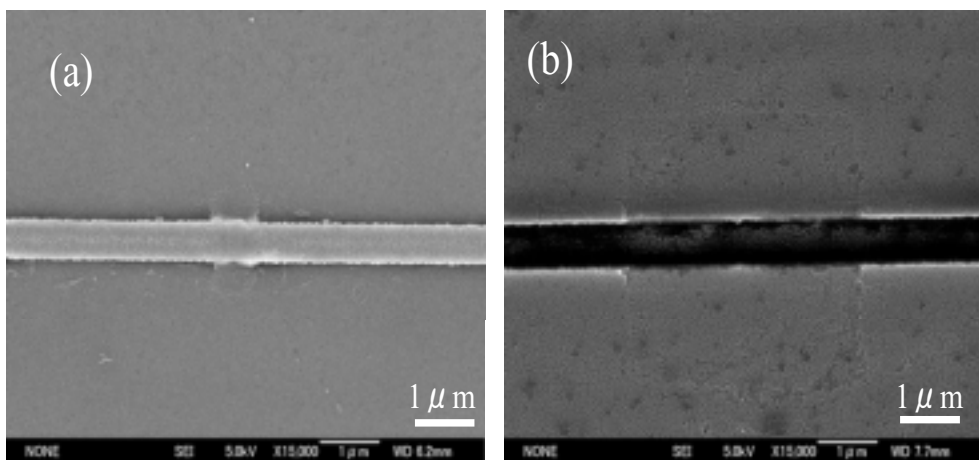
Fig.3 SEM images of (a) the repaired line on the mold and (b) the imprinted line onto PAK-01/Si substrate using the repaired mold.

Second, Spacer (Showa Denko K.K.) layer was spin-coated onto the defective mold for prevention of electrical charge. SiO_x deposition was carried out on the hollow defect by FIB-CVD at 30kV Ga⁺ and 0.4pA using tetraethoxysilane gas at 5.0x10⁻⁴Pa for about 3 minutes. After FIB-CVD, soaking in deionized water washed Spacer layer away. Figure 3(a) shows the repaired mold by FIB-CVD. Then, UV-NIL was carried out on PAK-01/Si substrate using the repaired mold. The imprinted line is shown in Fig. 3(b). The repaired line was successfully imprinted.
